# **Standard Building Inspection Report**

**For First Name at 1111 First Street, Tallahassee, FL**

## **Legacy Home Inspection**

**Report Number: Young 1754**  
**Email Address : [steve@alegacyhomeinspection.com](mailto:steve@alegacyhomeinspection.com)**  
**Phone: 850-893-3928**

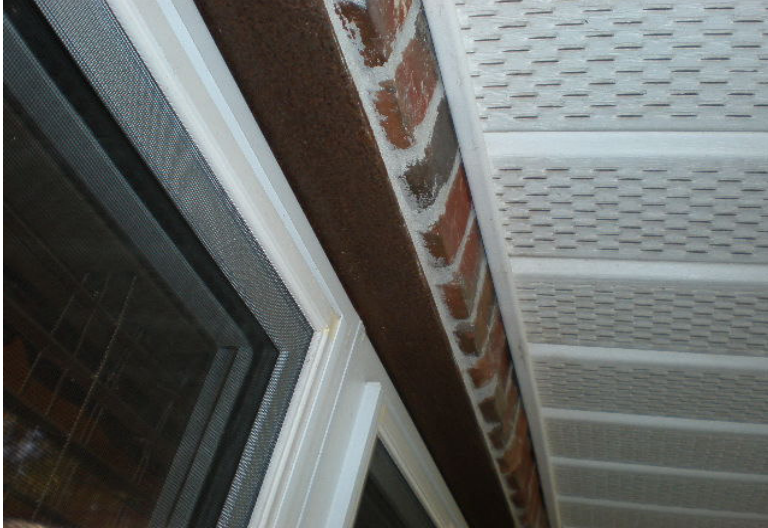
204. Rusted Lintels

Corrosion/rust noted to the lintels over the window openings. Recommend paint/seal.

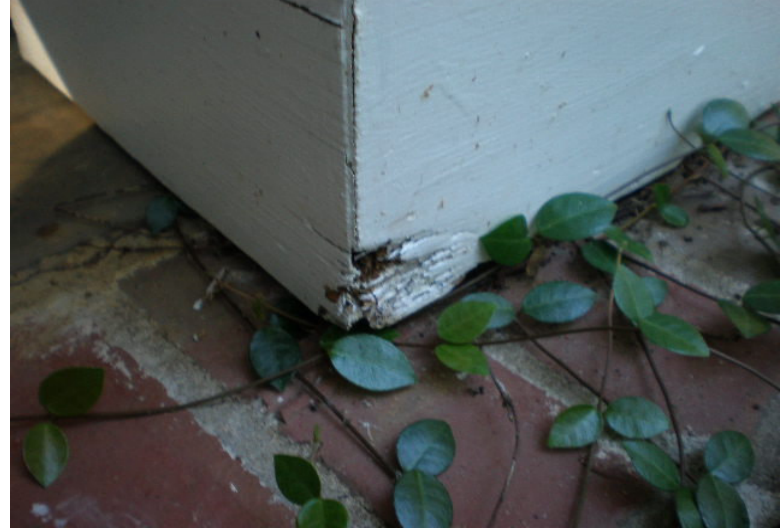
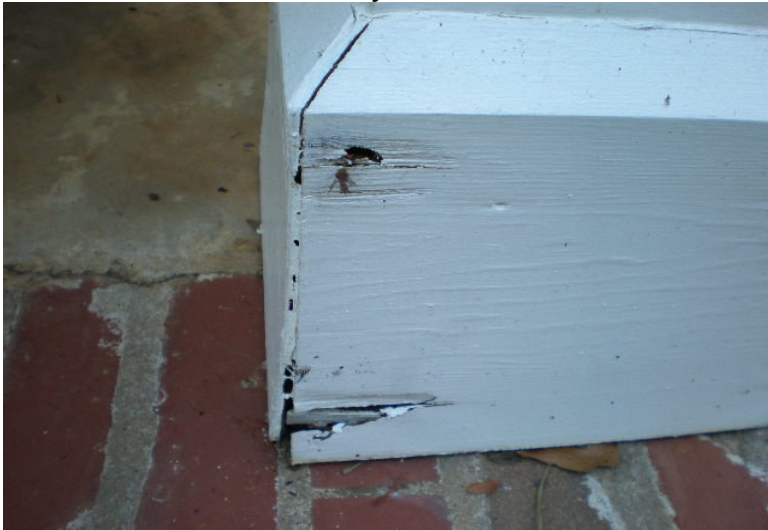
Wood rot was found at the bottom trim at two of the front porch posts.

213. Exterior Wood Rot/Decay

Repair needed.

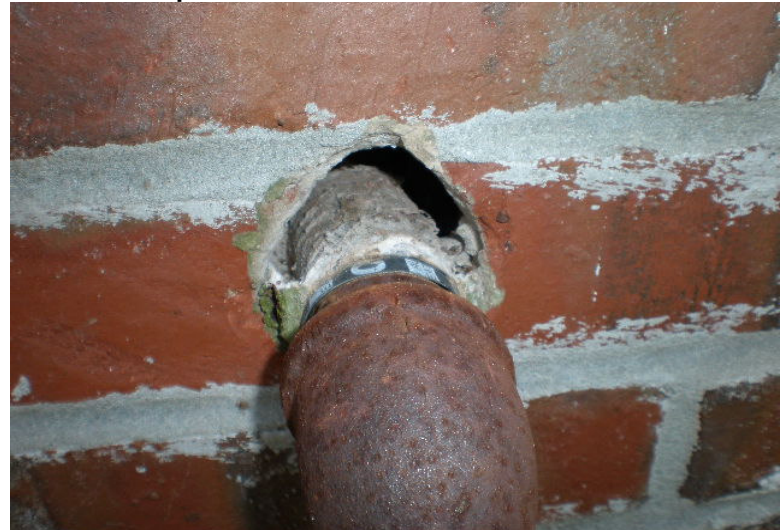
221. Seal/Re-point

Recommend seal/re-point around the gas pipe where it penetrates the brick veneer to prevent moisture intrusion.

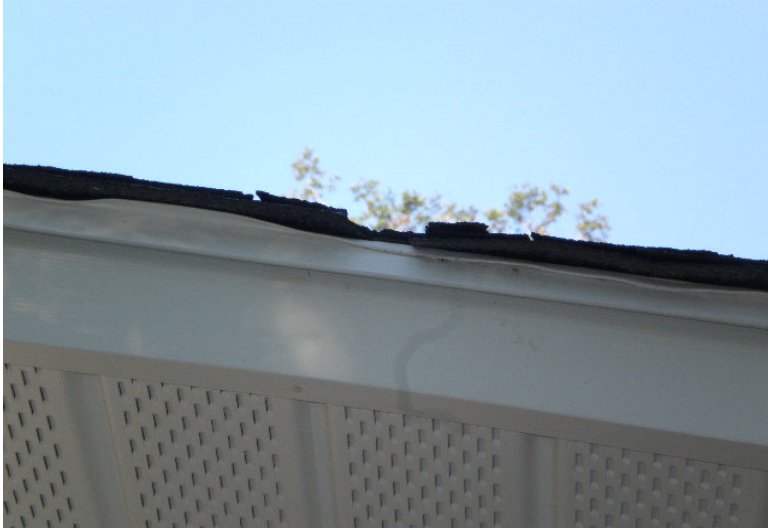
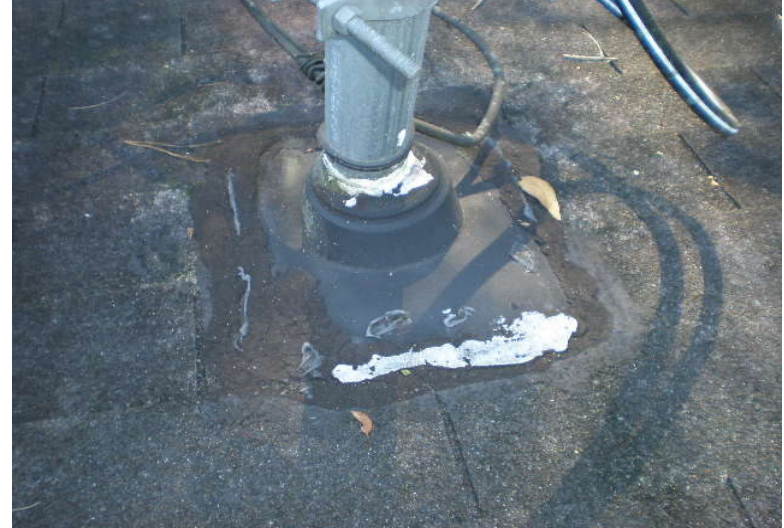
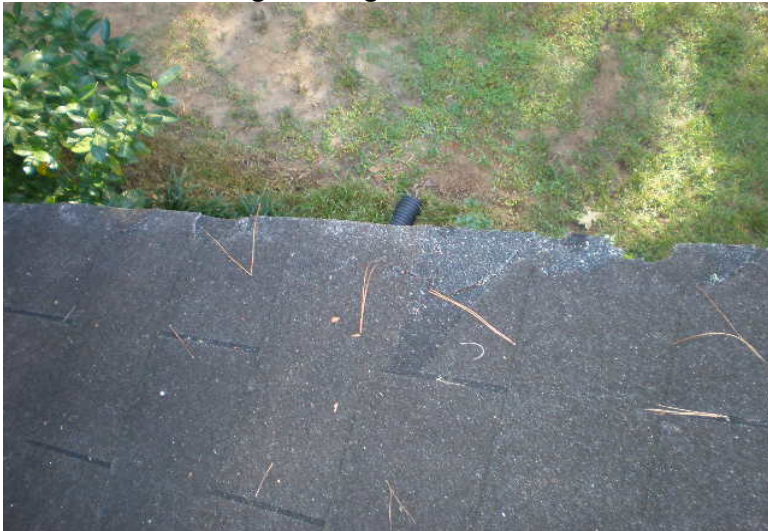
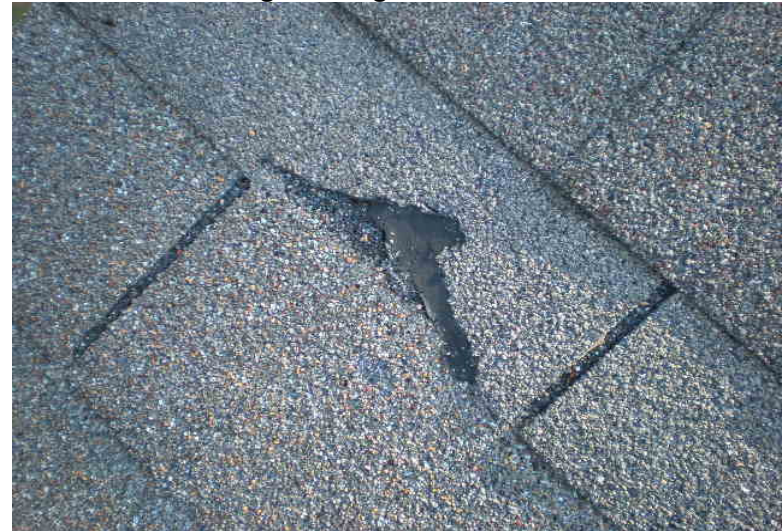
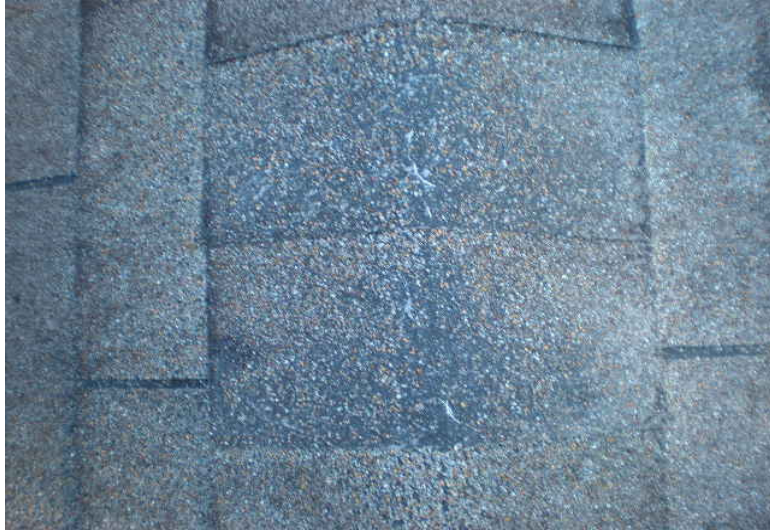
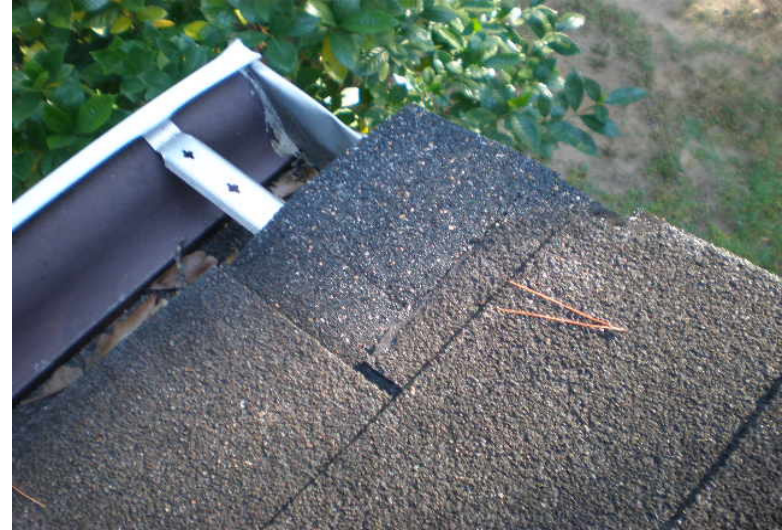
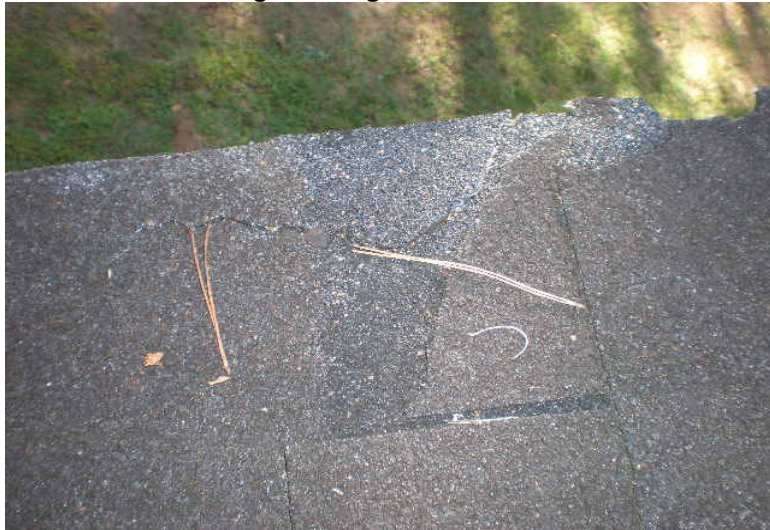
Cracked/damaged shingles and drip edge flashing noted along the left edge of the roof. Recommend further evaluation/repair by a roofing contractor. Previous repair noted at the neoprene boot for the electrical service mast. Check repair history with seller.

312. Cracked/Damaged Shingles

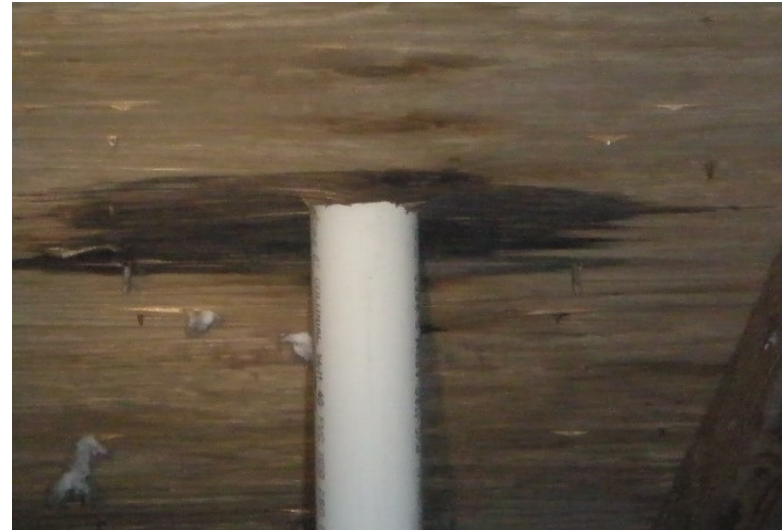
Moisture stain noted to the roof sheathing around the plumbing vent stack for the kitchen. No active leak evident at the time of the inspection. Check leak/repair history with seller.

332. Moisture Stains In Attic

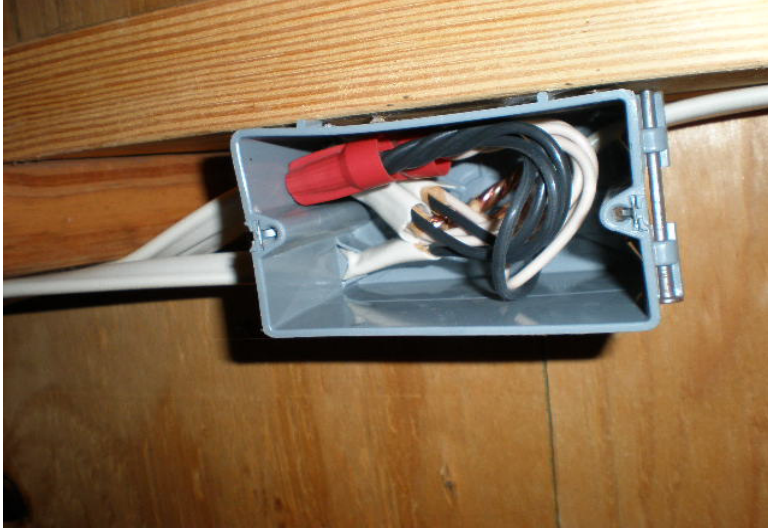
Open junction box found in the attic. Cover plate needed.

533. Open Junction Box/No Cover

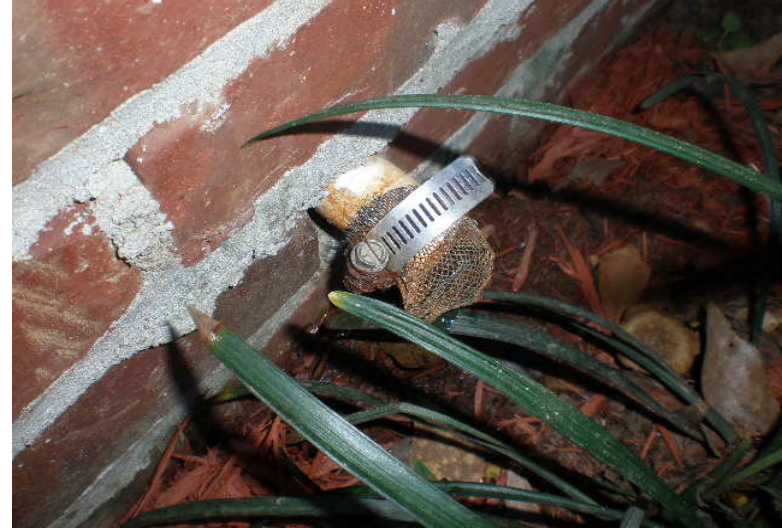
631. Extend Condensate Drain Line

Recommend extending the condensate drain line to keep moisture away from the foundation.

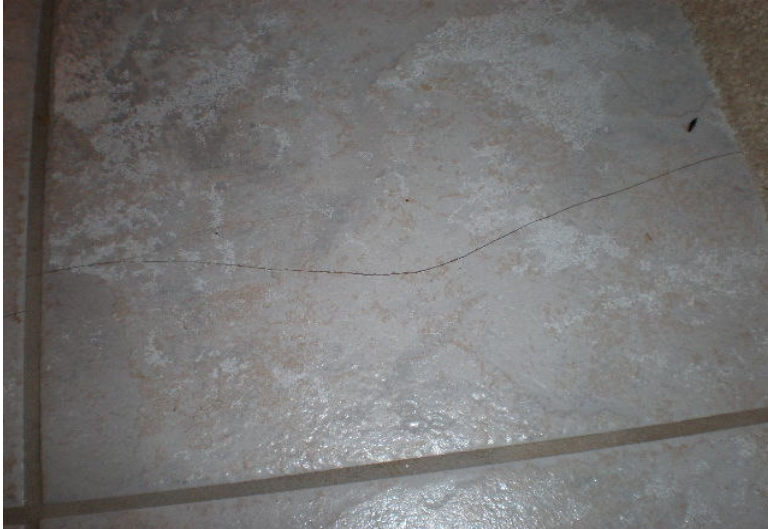
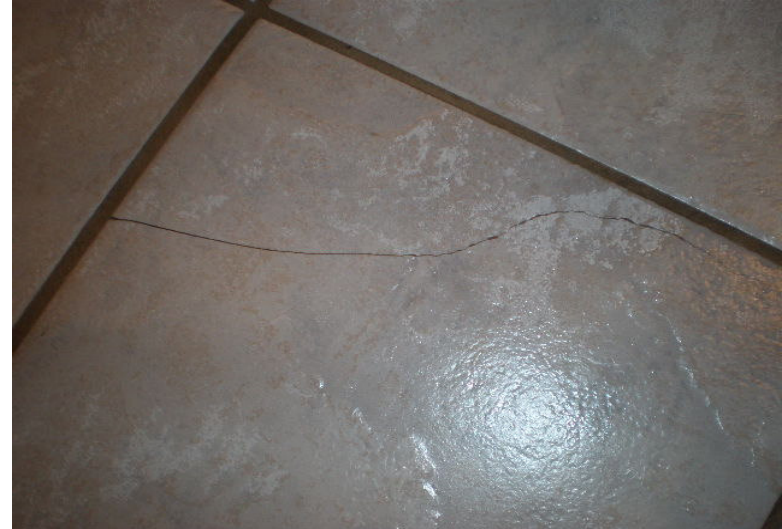
Various cracked floor tiles noted at the foyer and the kitchen/dining area. Repairs/tile replacement needed.

807. Cracked Floor Tiles
